**Evaluation of Public Safety at Run-of-River Dams
An Illinois State Wide Program**

JULY 20, 2007

APPENDIX V – Dam Investigations

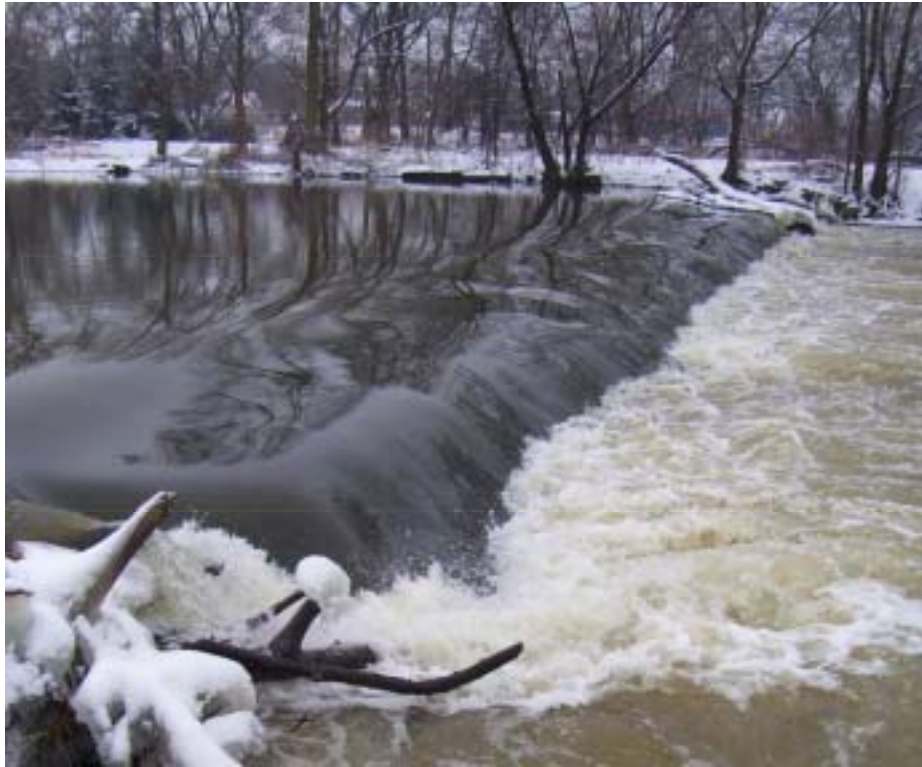
Photo 5.1.1.2 - 1 - Momence Dam, Kankakee River
Dam face from right abutment.

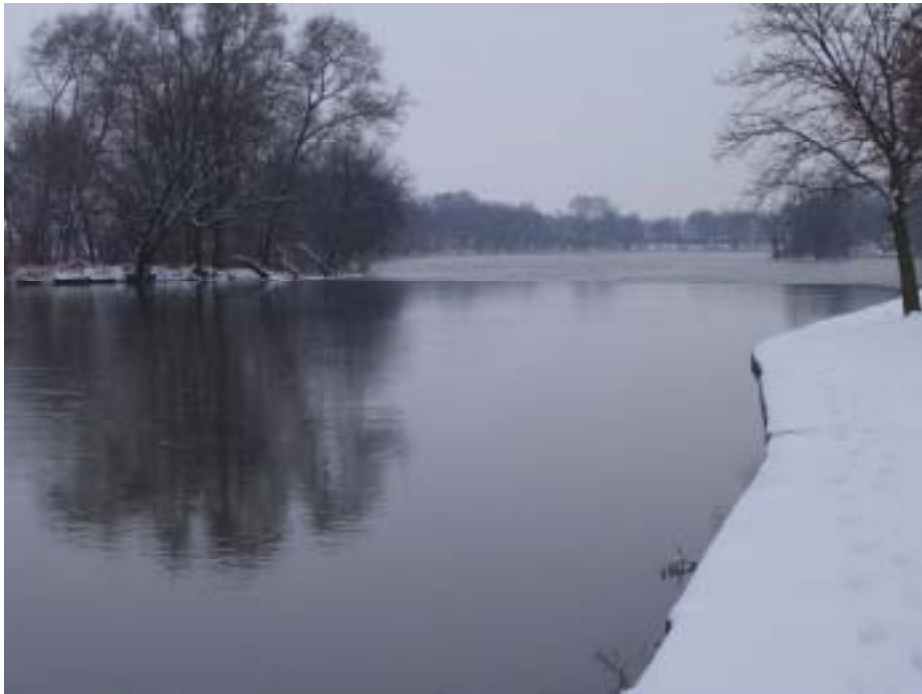
Photo 5.1.1.2 - 2 - Momence Dam, Kankakee River
View of dam from right bank, upstream.

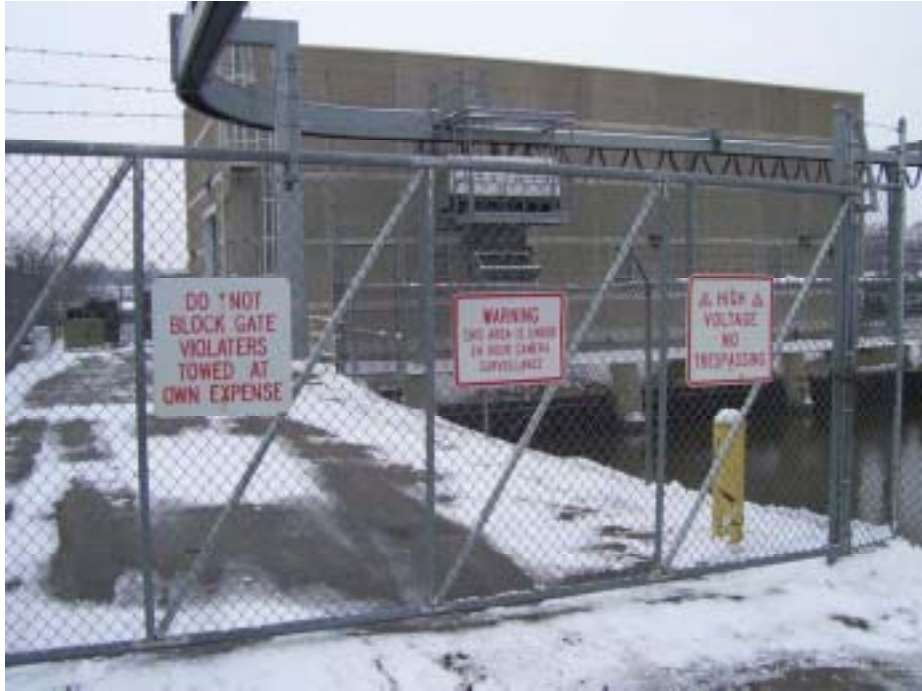
Photo 5.1.2.2 - 1 - Kankakee Dam, Kankakee River
Left bank at dam face. Kankakee Hydropower Dam and warning signage.

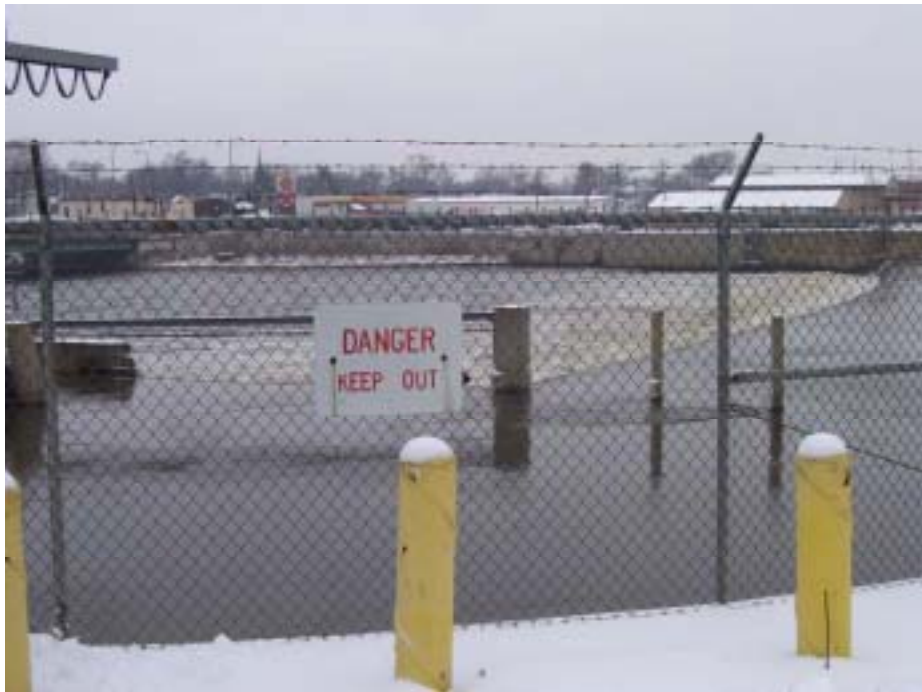
Photo 5.1.2.2 - 2 - Kankakee Dam, Kankakee River
Left Abutment at Hydropower Dam intake.

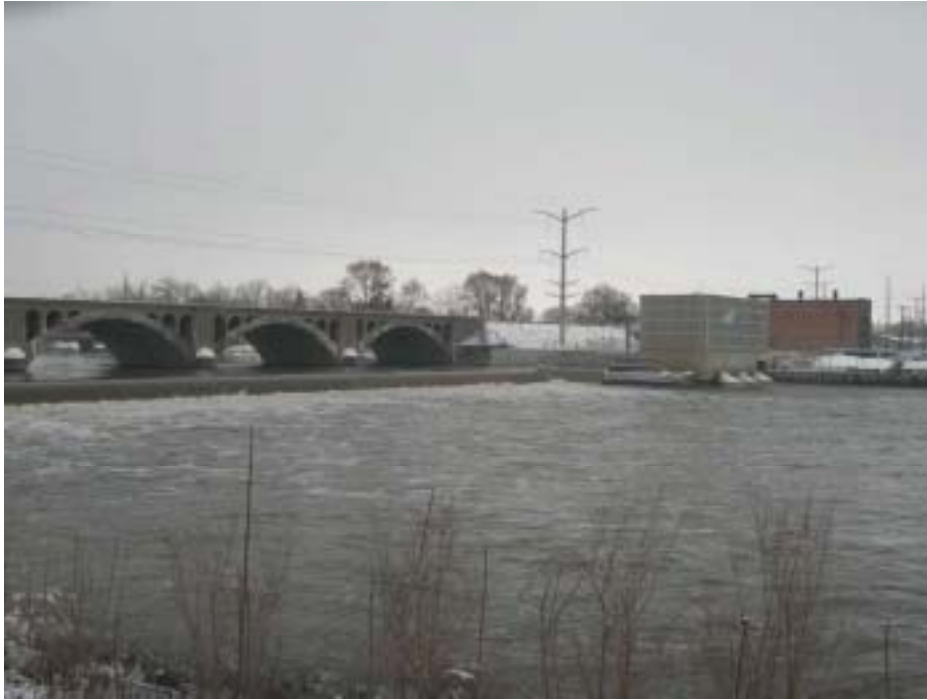
Photo 5.1.2.2 - 3 - Kankakee Dam, Kankakee River
View of dam from right bank.

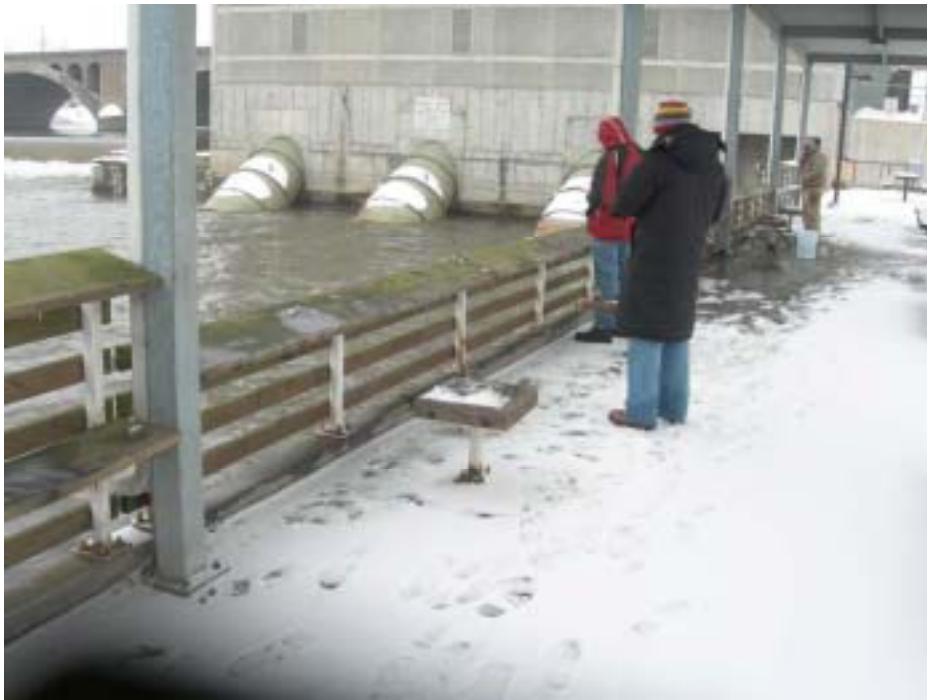
Photo 5.1.2.2 - 4 - Kankakee Dam, Kankakee River
Left bank, downstream. Fishing area.

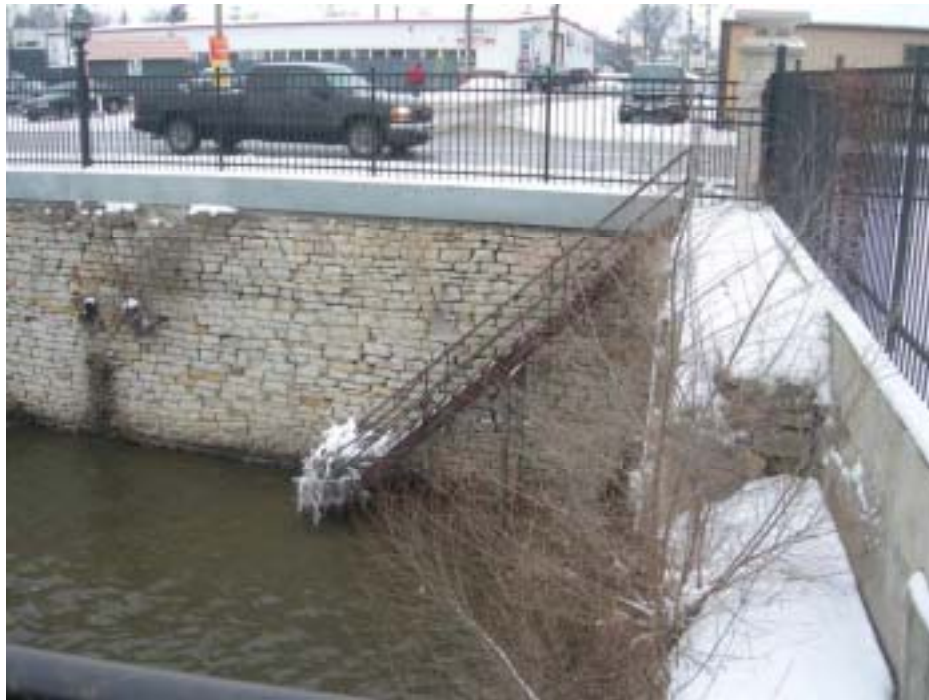
Photo 5.1.2.2 - 6 - Kankakee Dam, Kankakee River

Right bank, downstream. Access Stairway to downstream area of dam. Locked.

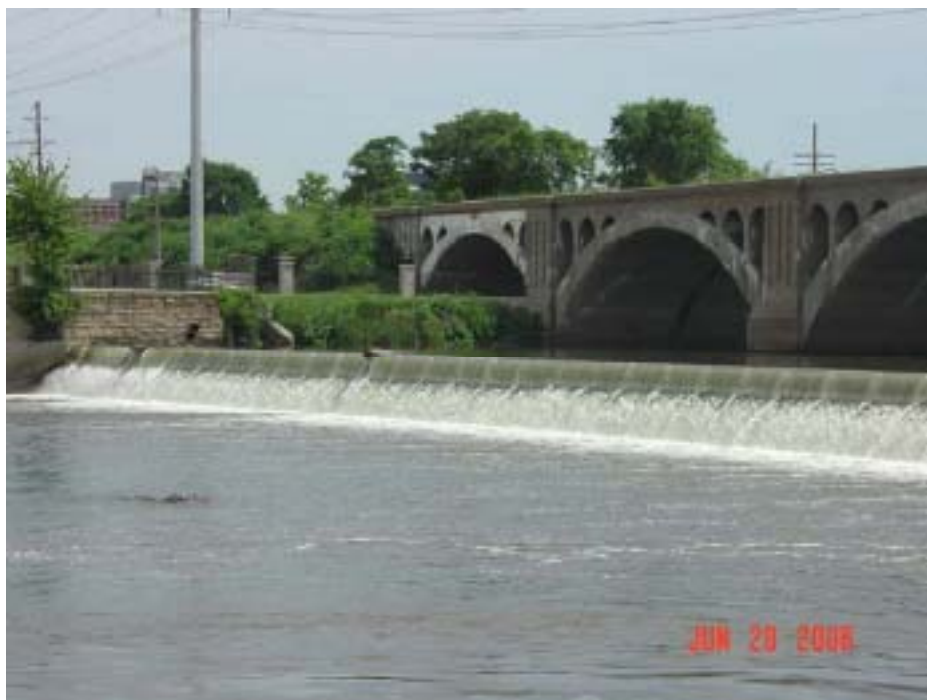
Photo 5.1.2.2 - 7 - Kankakee Dam, Kankakee River
Dam face, from left bank. (IDNR, 2006)

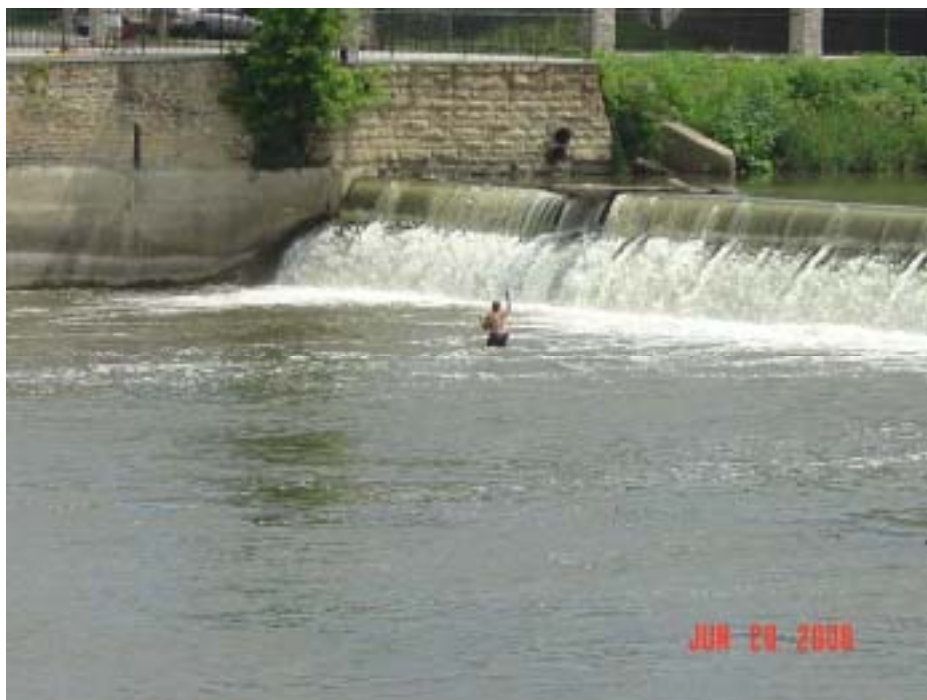
Photo 5.1.2.2 - 8 - Kankakee Dam, Kankakee River
Fisherman near roller. (IDNR, 2006)

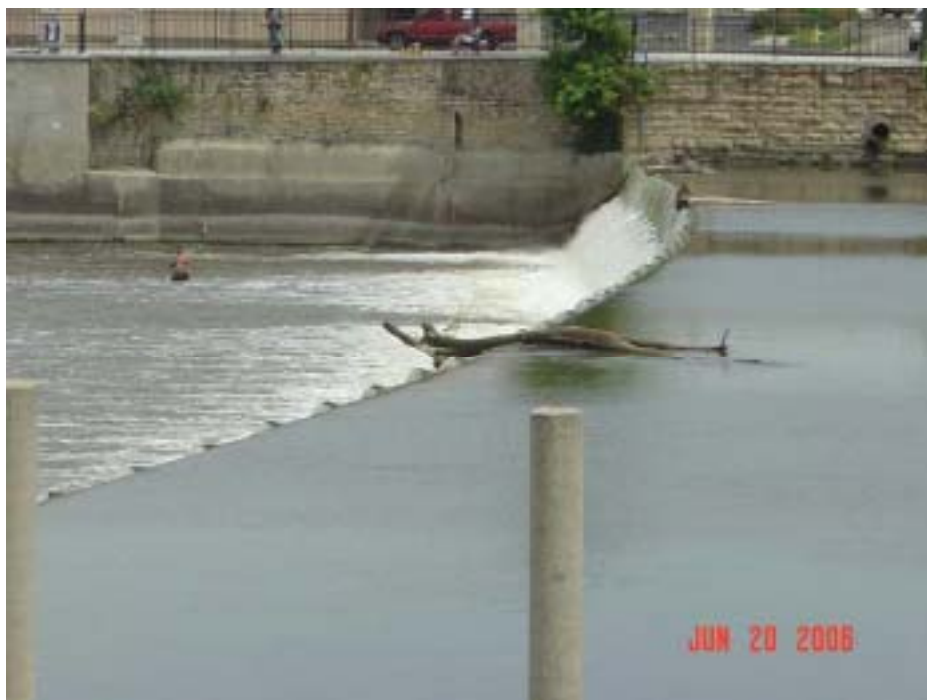
Photo 5.1.2.2 - 9 - Kankakee Dam, Kankakee River
Fisherman near roller. (IDNR, 2006)

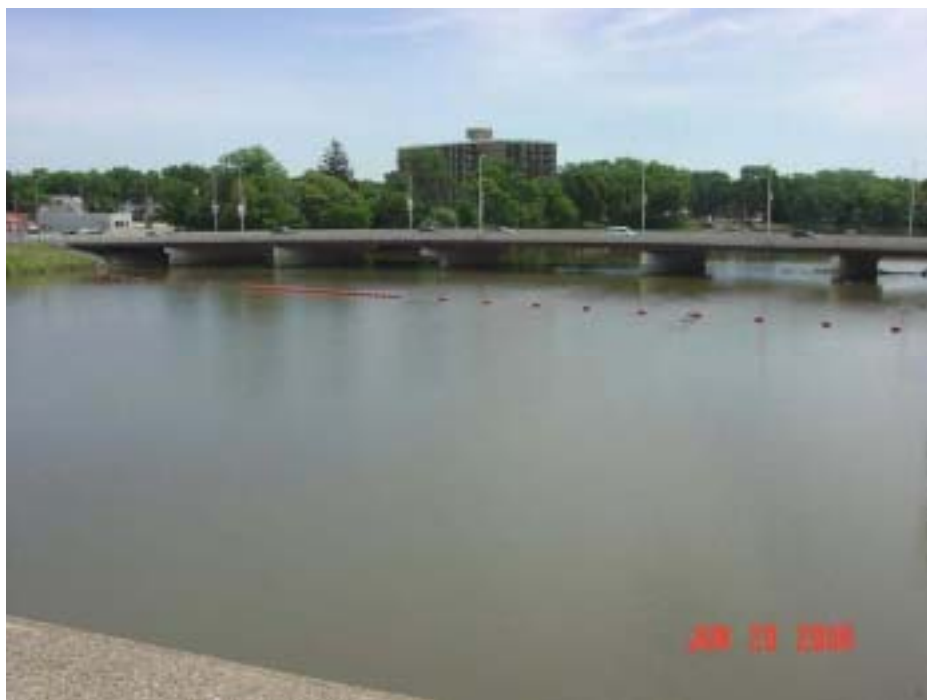
Photo 5.1.2.2 - 10 - Kankakee Dam, Kankakee River
Boat line, looking downstream. (IDNR, 2006)

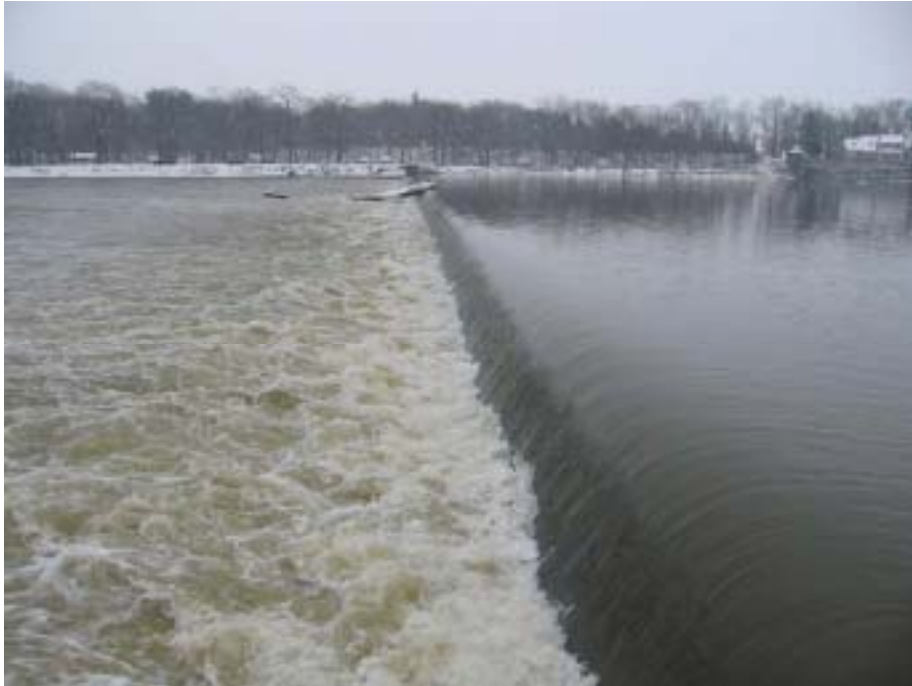
Photo 5.1.3.2 -1 - Wilmington Dam, Kankakee River
Dam face from left abutment. View of very strong roller.

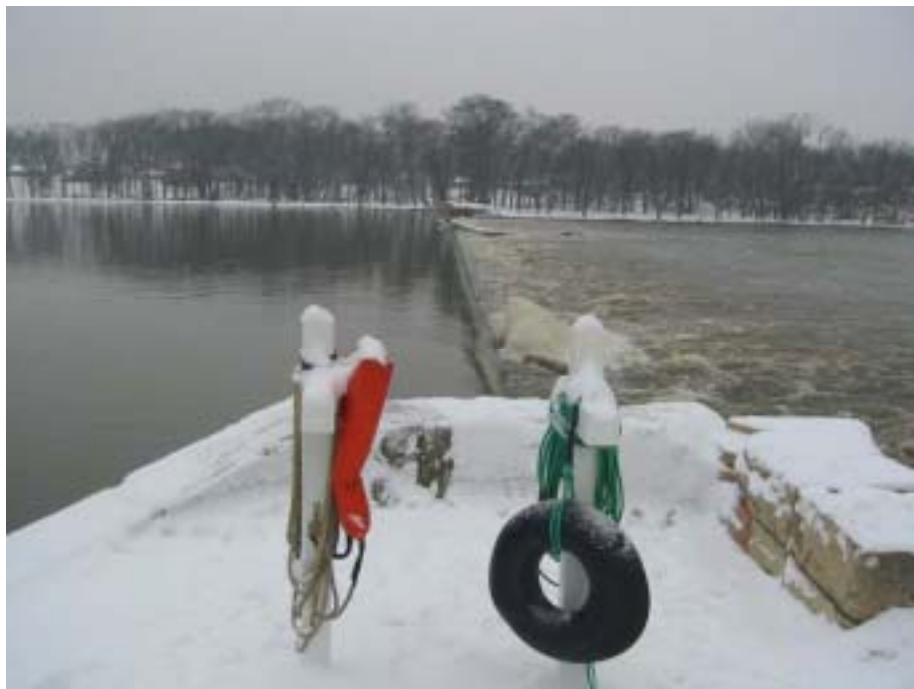
Photo 5.1.3.2 - 2 - Wilmington Dam, Kankakee River
Life saving equipment on right abutment.

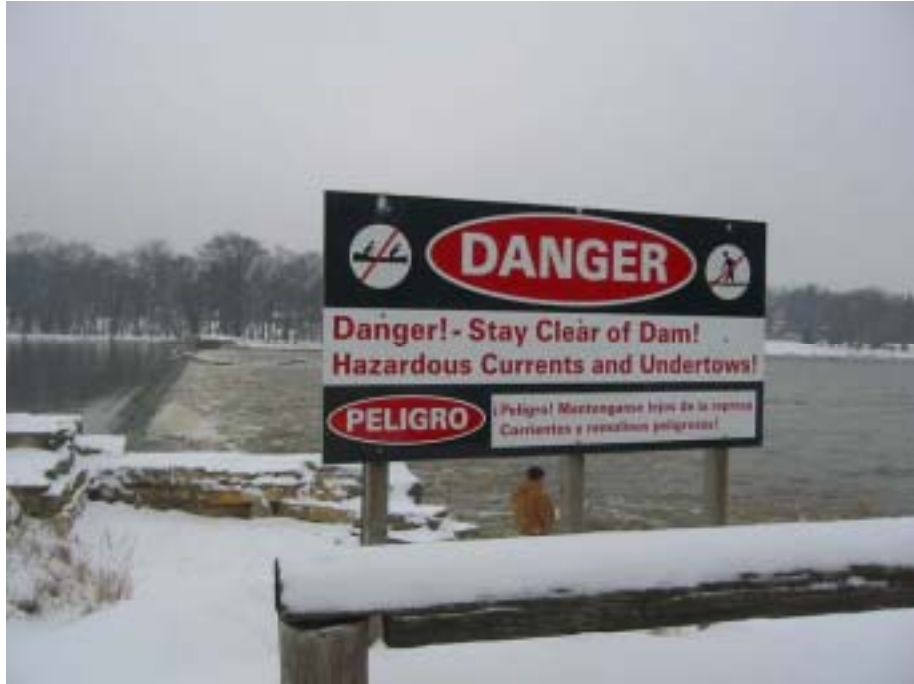
Photo 5.1.3.2 - 3 - Wilmington Dam, Kankakee River
Large letter warning sign on right bank.

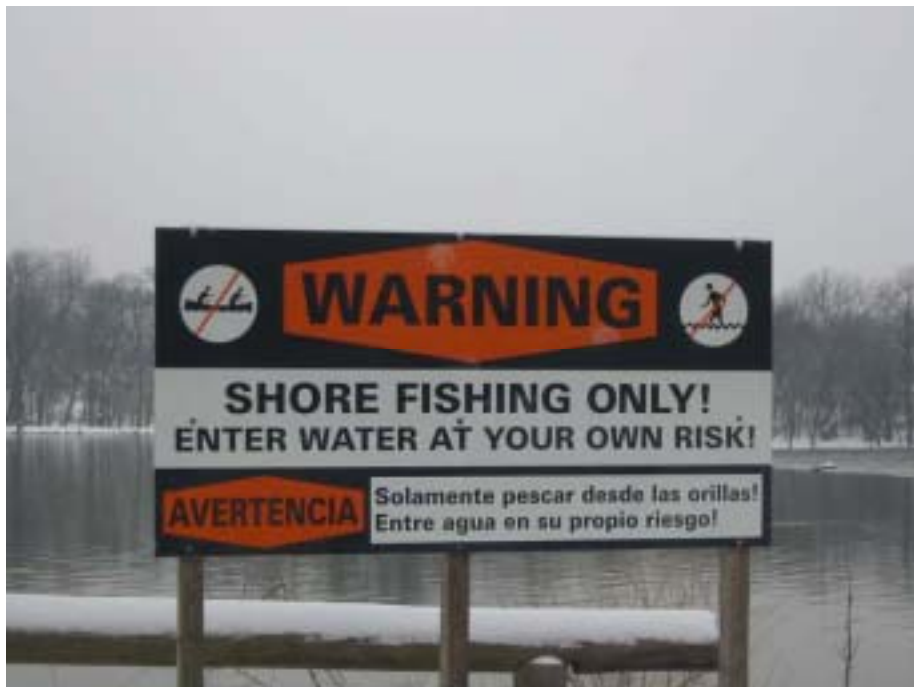
Photo 5.1.3.2 - 4 - Wilmington Dam, Kankakee River
Large letter warning sign for fishermen on right bank.

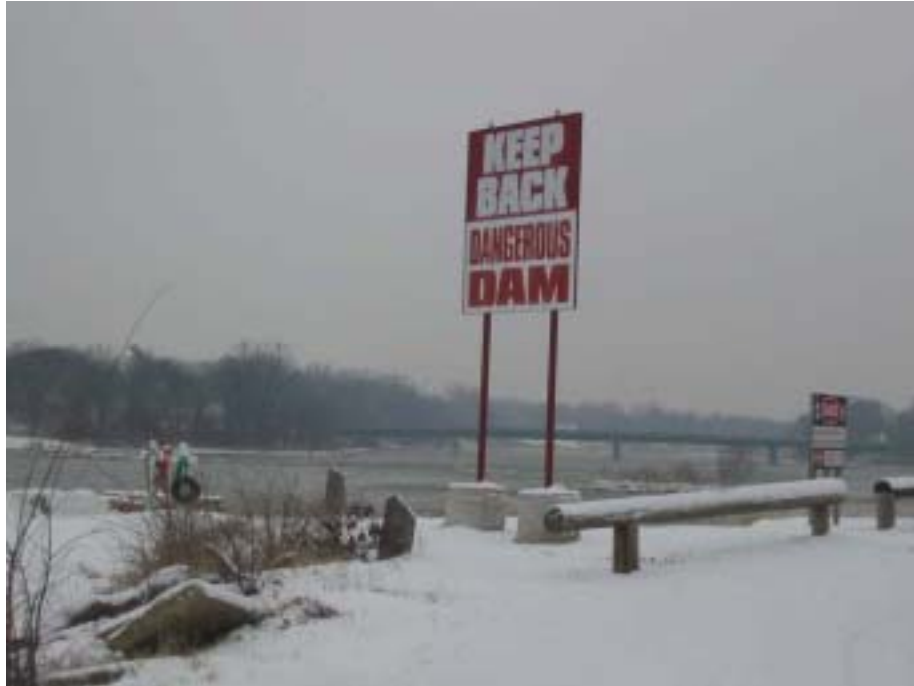
Photo 5.1.3.2 - 5 - Wilmington Dam, Kankakee River
Large elevated warning sign for upstream river users, at right abutment.

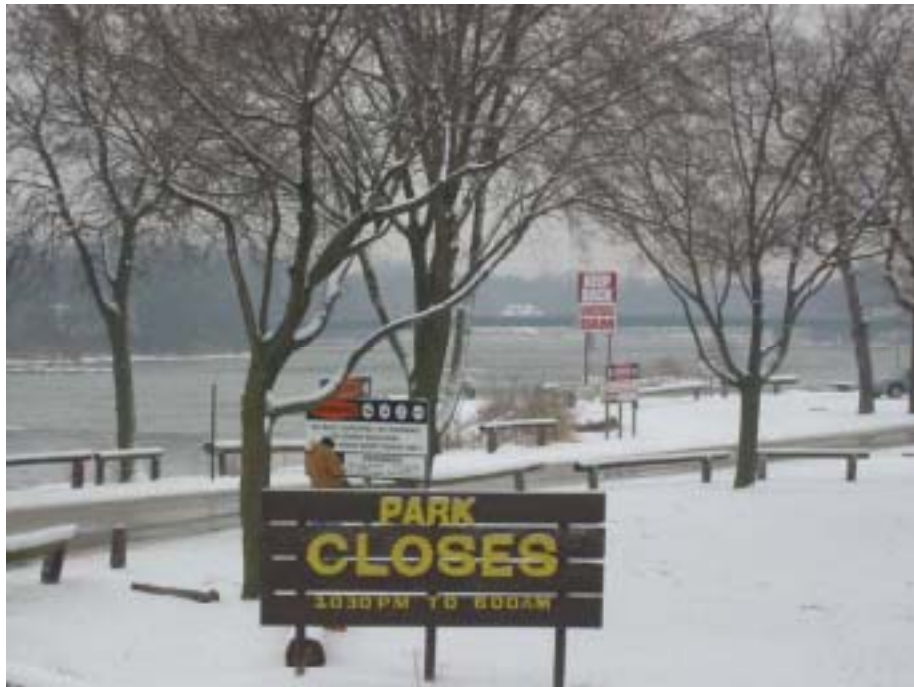
Photo 5.1.3.2 - 6 - Wilmington Dam, Kankakee River
View of various signage on right abutment.

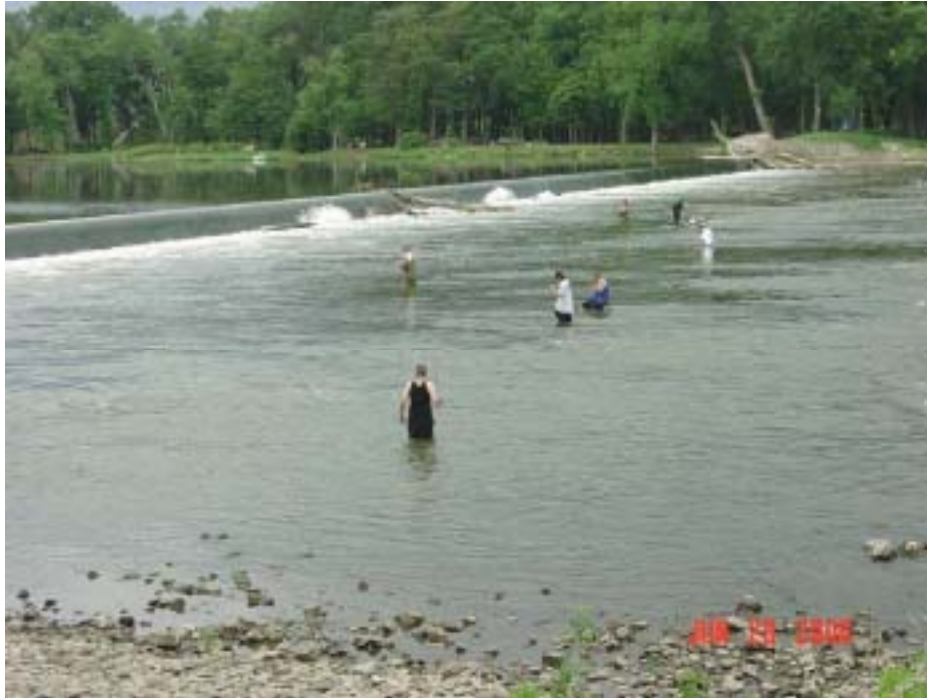
Photo 5.1.3.2 - 7 - Wilmington Dam, Kankakee River
Fishermen near dam. (IDNR, 2006)

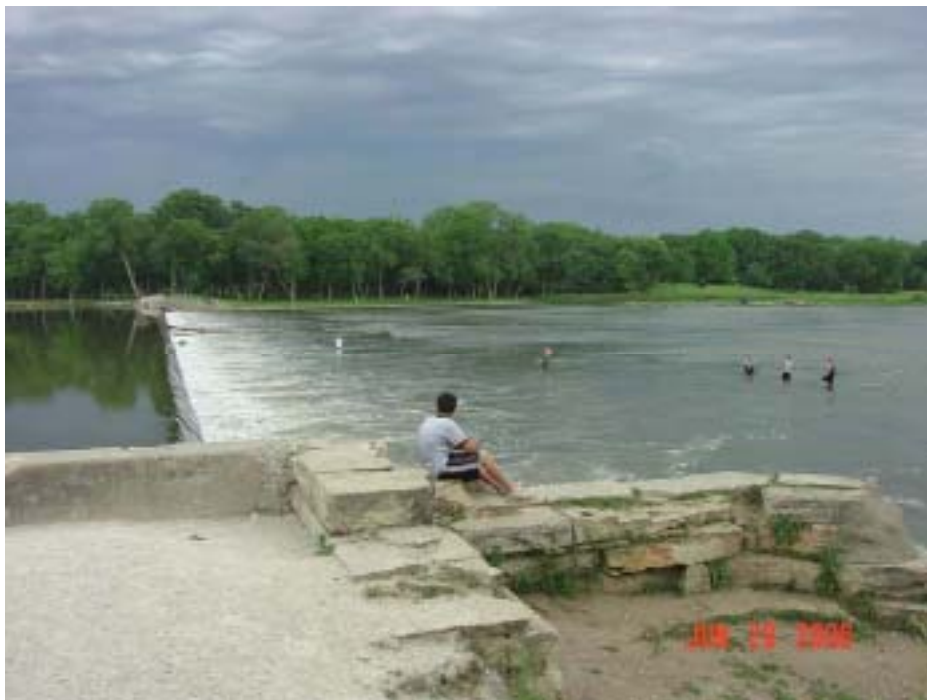
Photo 5.1.3.2 - 8 - Wilmington Dam, Kankakee River
Fishermen at dam. (IDNR, 2006)

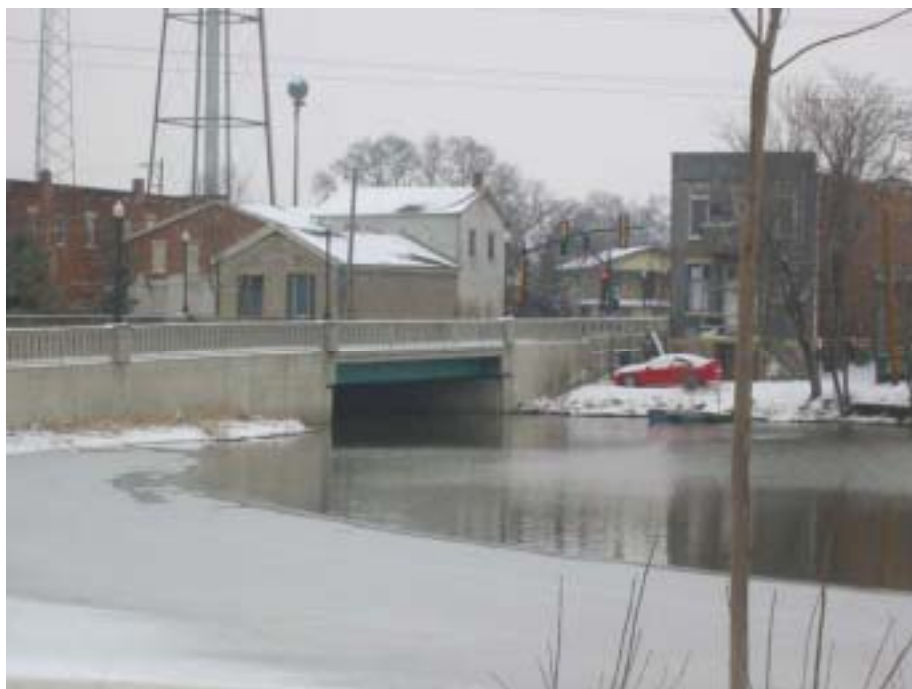
Photo 5.1.4.2- 1 - Wilmington Millrace Dam, Kankakee River
Bridge upstream of dam. No warning signage for downstream dam.

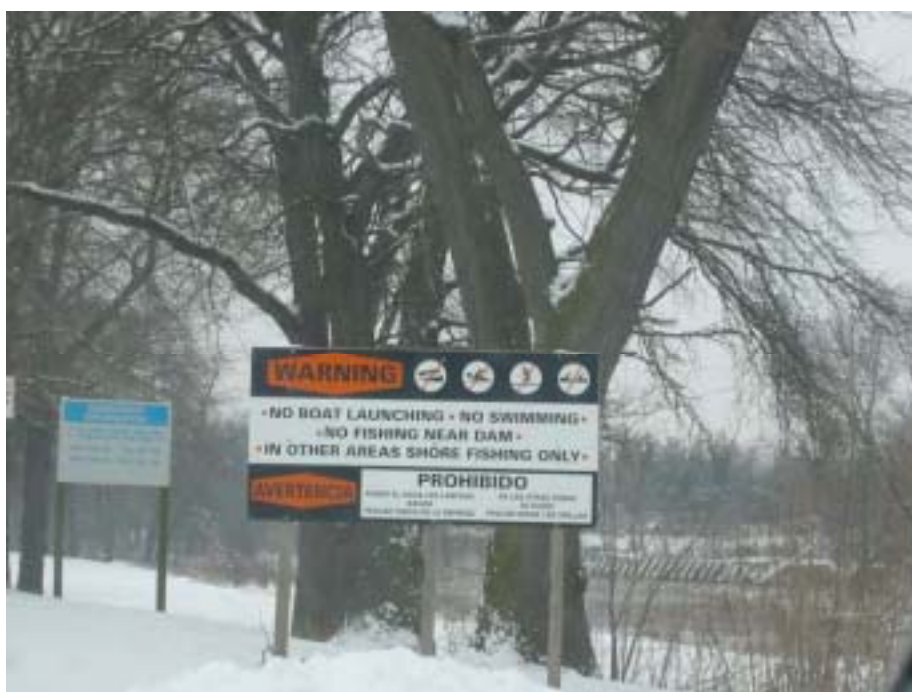
Photo 5.1.4.2- 2 - Wilmington Millrace Dam, Kankakee River
Large letter warning sign on left bank.

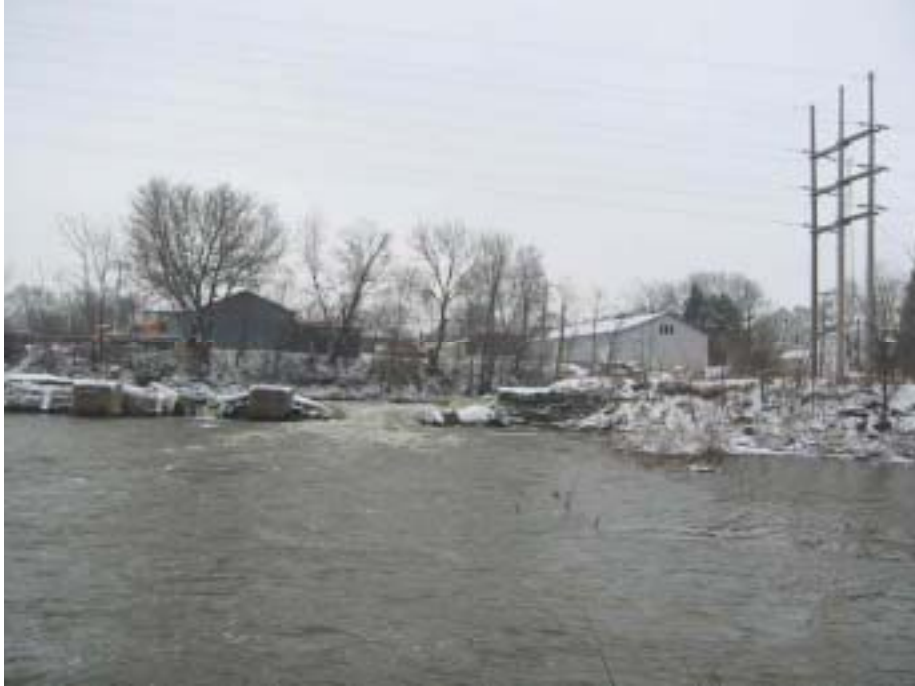
Dam appears to have been constructed from large concrete blocks and has partially failed near the left abutment. The partial failure has resulted in a series of drops over approximately 60 feet. The total drop is approximately 10 feet. The right abutment is concrete with some deterioration and cracking and is in need of inspection. Left abutment appears to be a breached retaining wall which resulting in the partial failure. Its condition is uncertain and should be inspected.

Photo 5.1.4.2- 3 - Wilmington Millrace Dam, Kankakee River
View of dam from downstream.

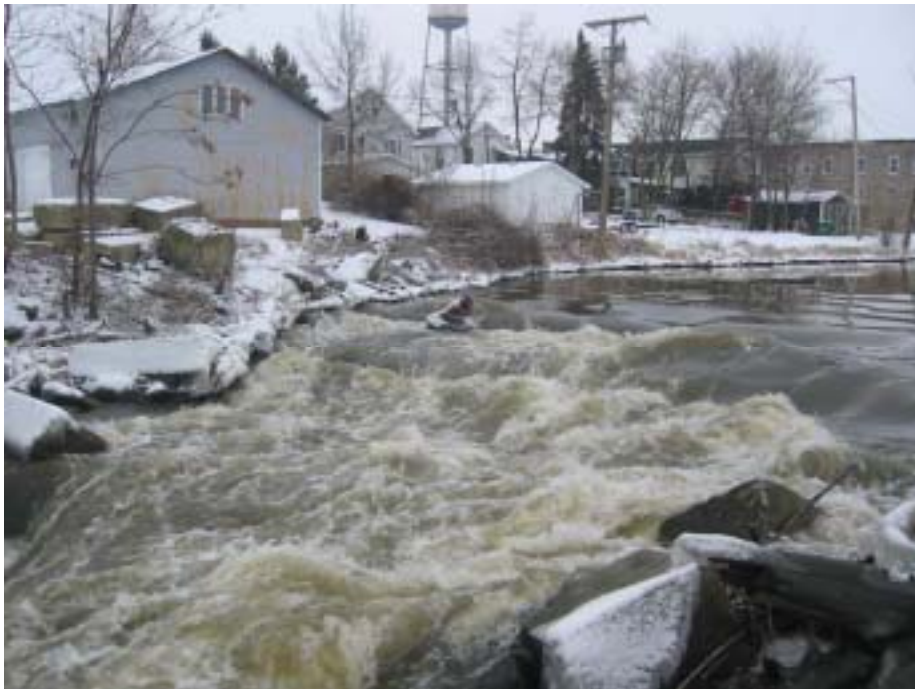
Photo 5.1.4.2- 4 - Wilmington Millrace Dam, Kankakee River
Dam at upstream.

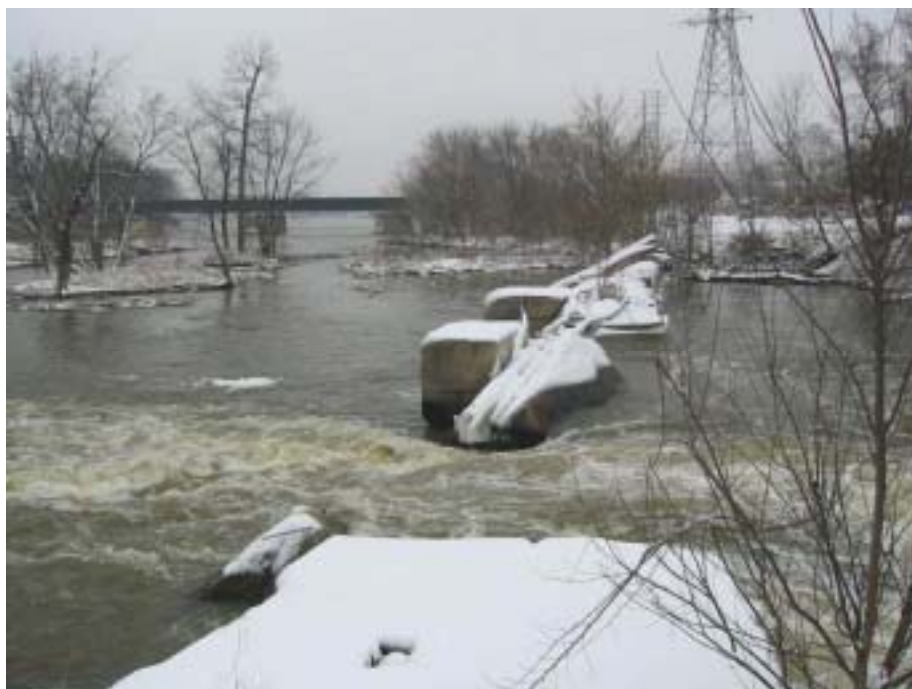
Photo 5.1.4.2- 5 - Wilmington Millrace Dam, Kankakee River
Dam at downstream. Abutments visible.

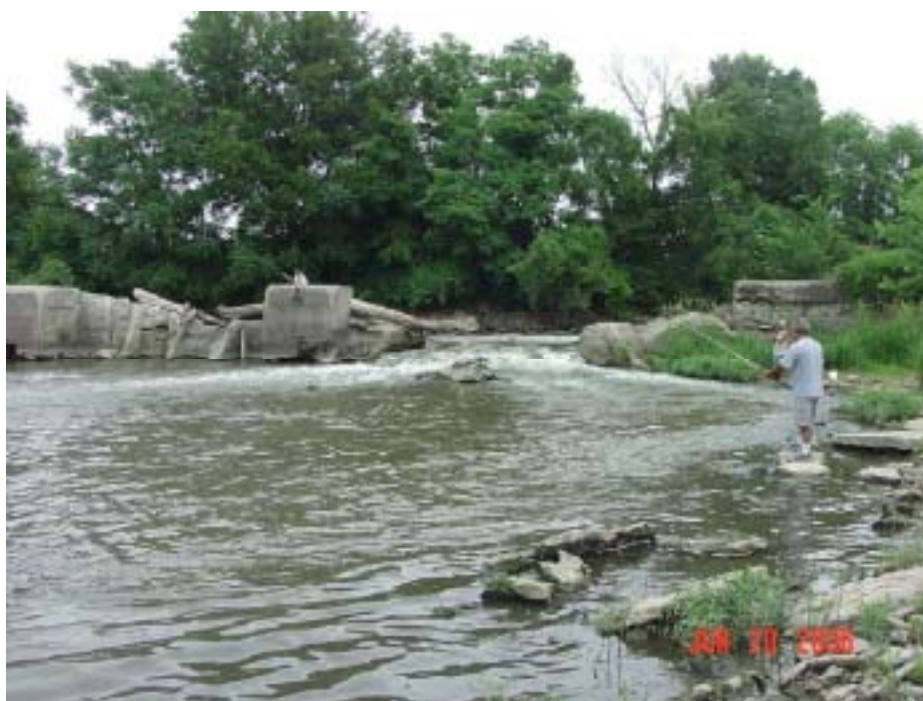
Photo 5.1.4.2- 6 - Wilmington Millrace Dam, Kankakee River
Fishermen downstream of dam. (IDNR, 2006)

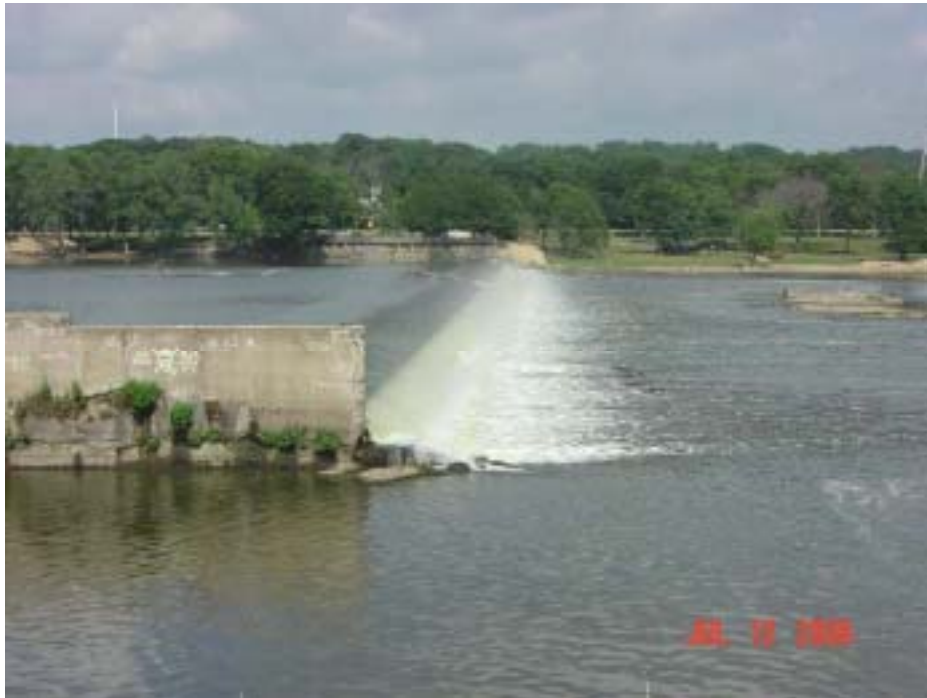
Photo 5.2.1.2 – 1 – Oregon Dam, Rock River
Dam from Right Bank. Note Warning on Abutment. (IDNR, 2006)

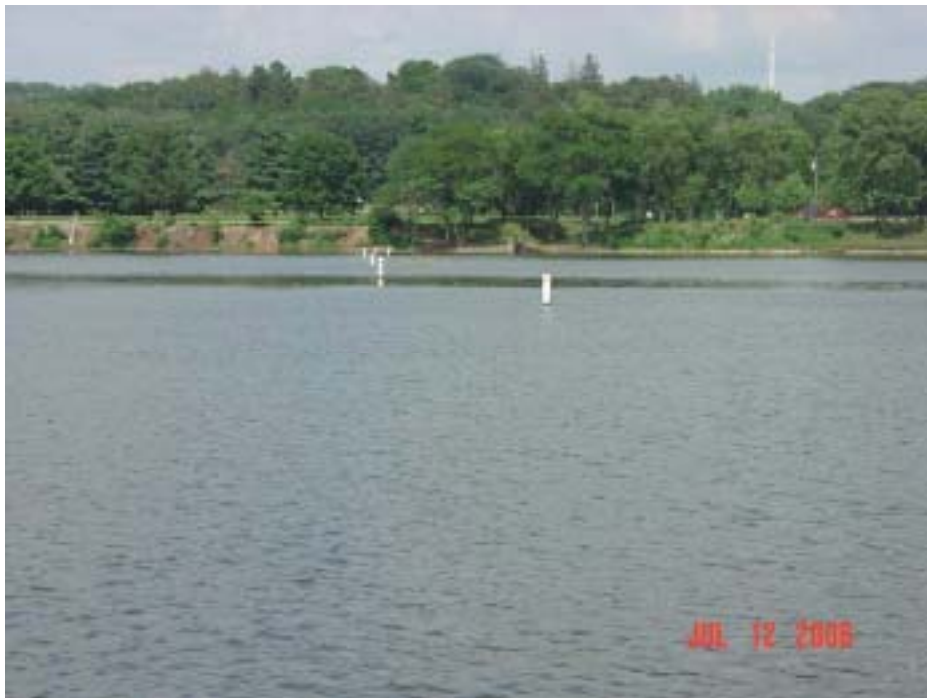
Photo 5.2.1.2 – 2 – Oregon Dam, Rock River
Seasonal Warning Buoys. (IDNR, 2006)

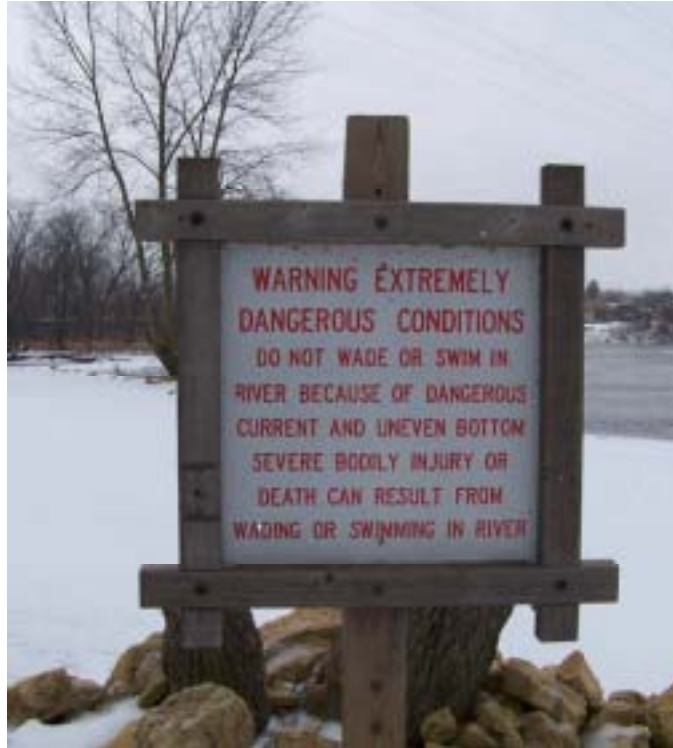
Photo 5.2.1.2 – 3 – Oregon Dam, Rock River
Warning Signage on Left Bank, Downstream of Abutment
This sign posted on left and right banks below dam.

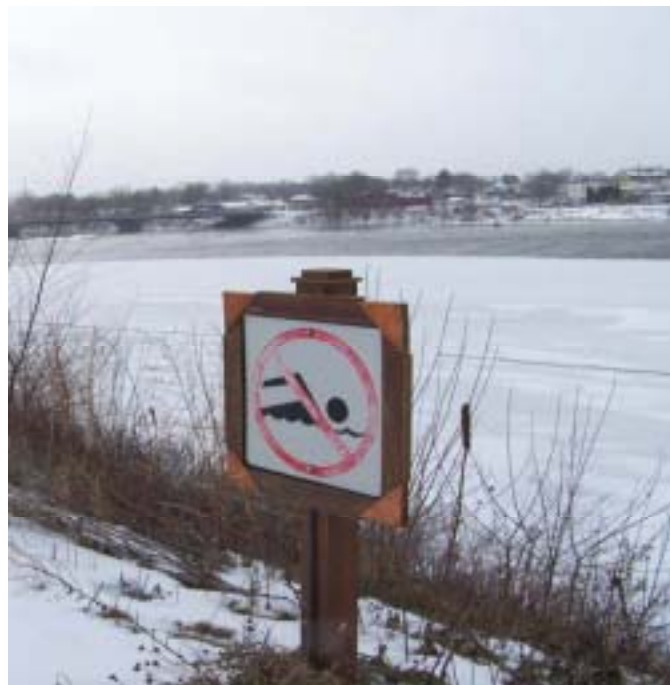
Photo 5.2.1.2 – 4 – Oregon Dam, Rock River
Warning Signage on Left Bank, Above dam.

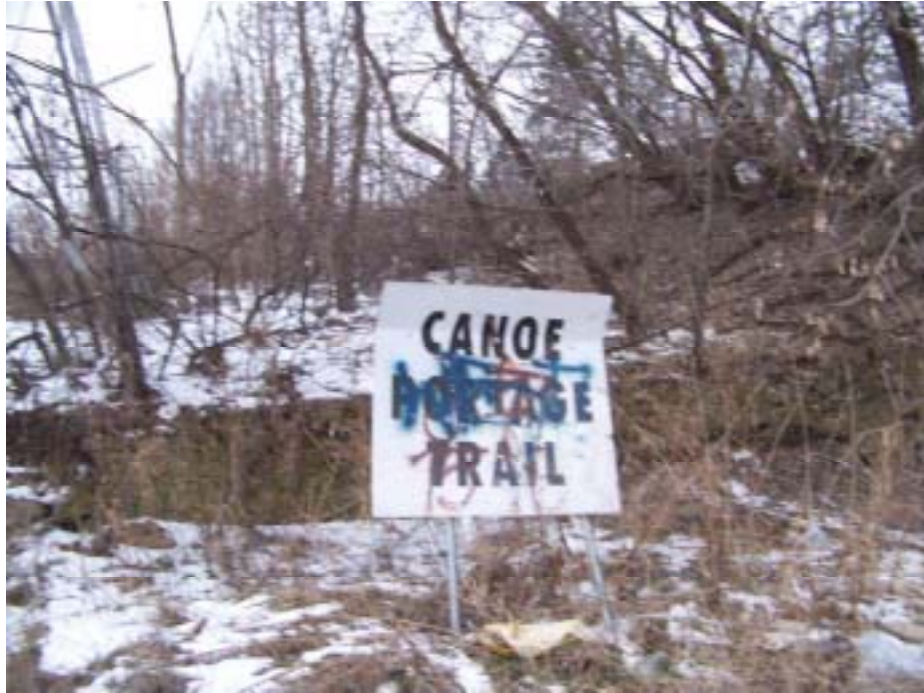
Photo 5.2.2.2 - 1 - Sinnissippi Dam, Rock River
Defaced portage sign on right bank

- 1) Dam has some warning signage that clearly define the danger. These are to close to the dam and are difficult for boaters to see, though portage signs for right bank portage need to be repaired/replace due to vandalism.
- 2) Tree growth on upstream side of right bank earthen abutment needs to be removed as was done on downstream side.

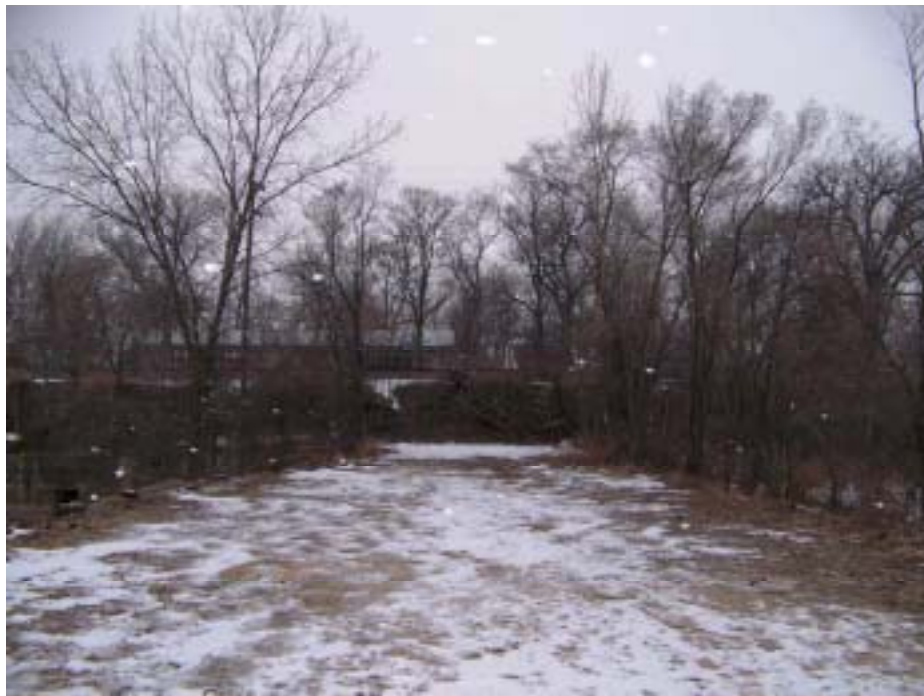
5.2.2.2 - 2 - Sinnissippi Dam, Rock River
Looking shoreward from right bank: note trees stumps on left, downstream, and trees to be cut on right, upstream face of dam.

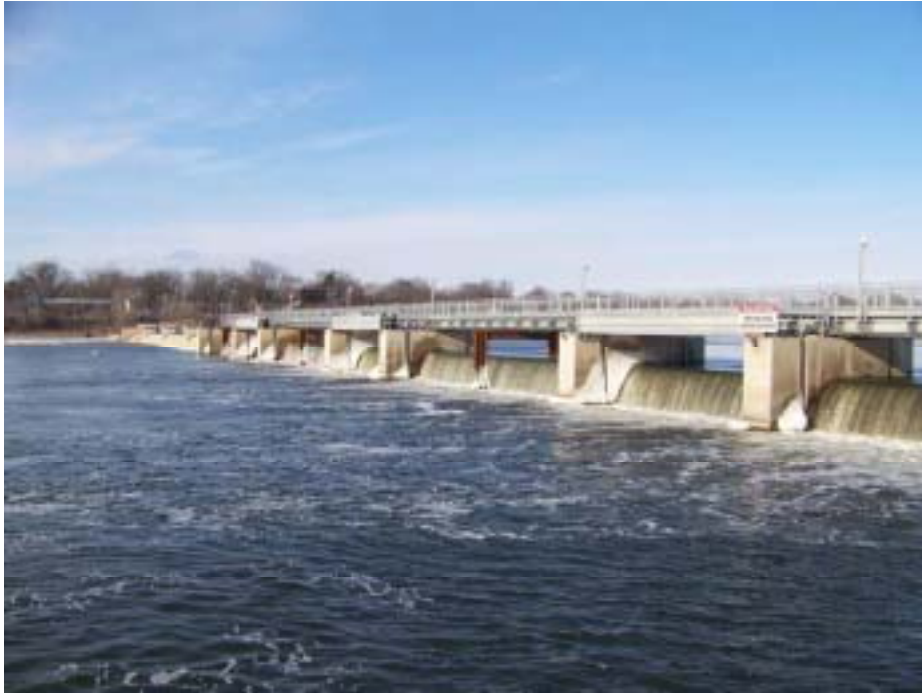
5.2.2.2 - 3 - Sinnissippi Dam, Rock River

Looking upstream from left bank; roller visible clearly.

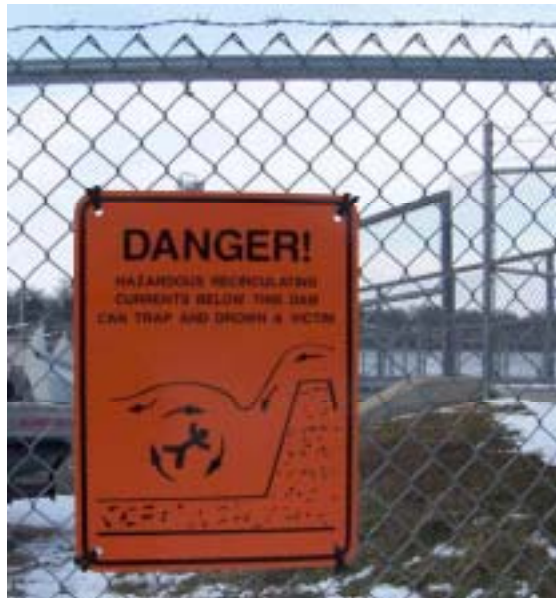
5.2.2.2 - 4 - Sinnissippi Dam, Rock River

Excellent signage upstream on left bank.

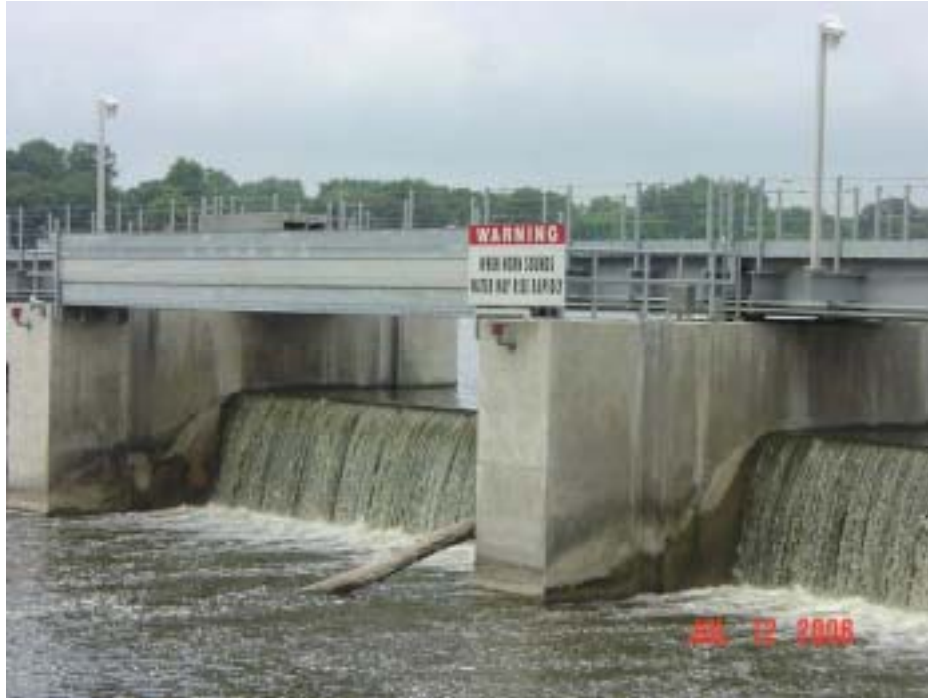
5.2.2.2 - 5 - Sinnissippi Dam, Rock River
Warning Signage on Dam Face. (IDNR, 2006)

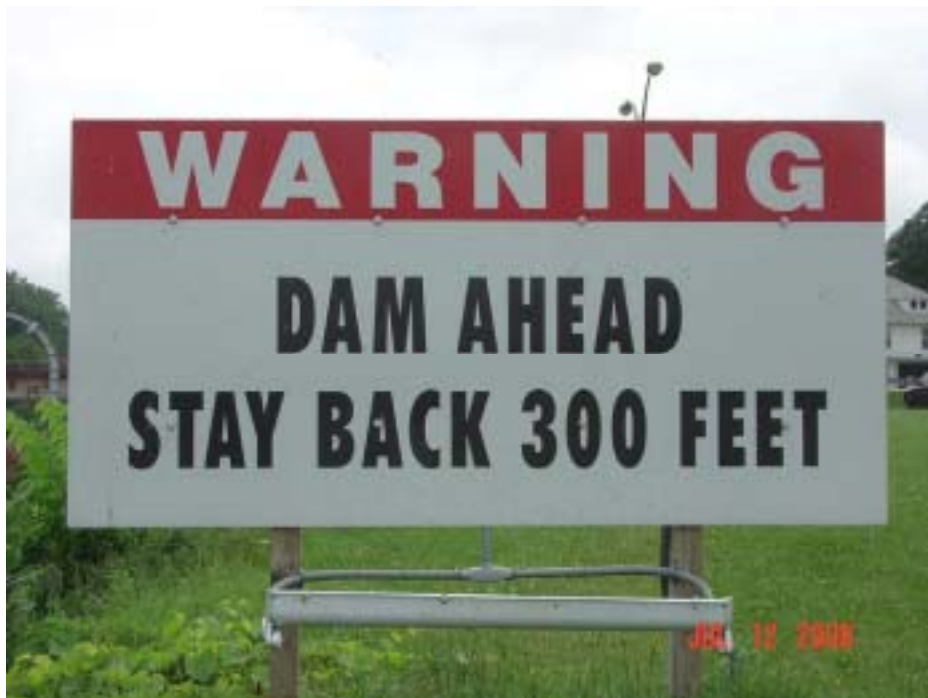
5.2.2.2 - 6 - Sinnissippi Dam, Rock River
Warning Signage on Bank. (IDNR, 2006)
